AB13 10 24 July 2013

## Load Shift due to Heavy Braking

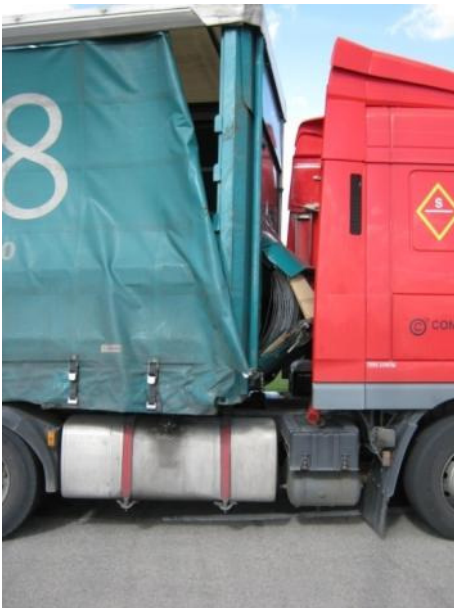
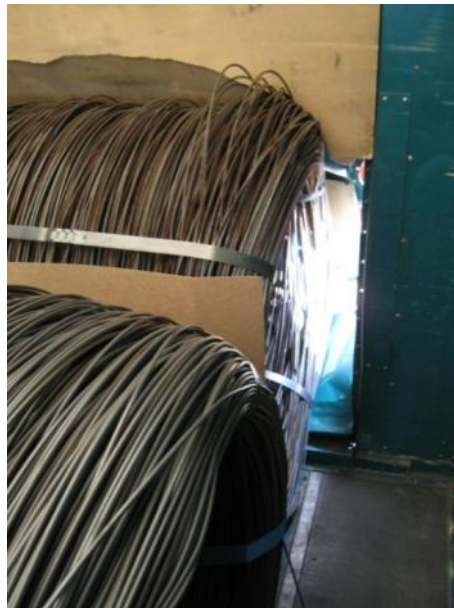
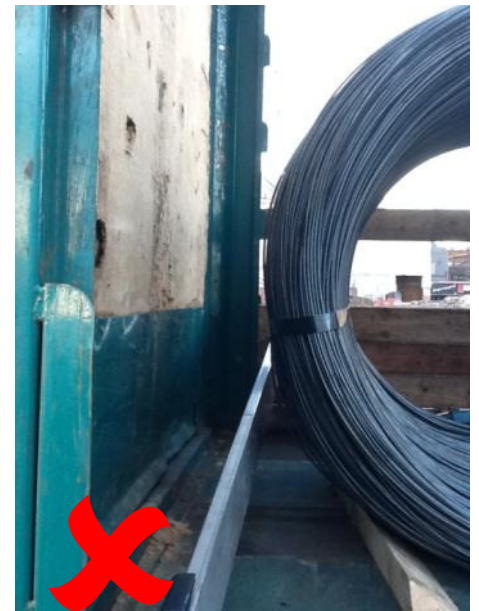
On 17<sup>th</sup> April 2013 a driver with a full load travelling to Barcelona, was forced to brake heavily to avoid a collision on the M1 southbound. The coils moved forward partially through the trailer headboard severing the air and electrical cables rendering trailer and truck immovable. Driver informed his company who informed P&O, coils were recovered and reloaded to another trailer and returned to the customer for inspection.

Returned load

- Load shifted due to a combination of insufficient tension in the webbing straps during securing and the heavy braking.

- All straps must be checked for sufficient tension before leaving loading points by Load Checkers/ Safety Inspectors.
- Loads to be photographed before departure to confirm load security and cargo condition.
- Where transshipment is needed then advice Must be sought prior to steel handling and applying Load Restraint.
