AB14 10 6th August 2014

Driver Injured by Falling Roof Support Post

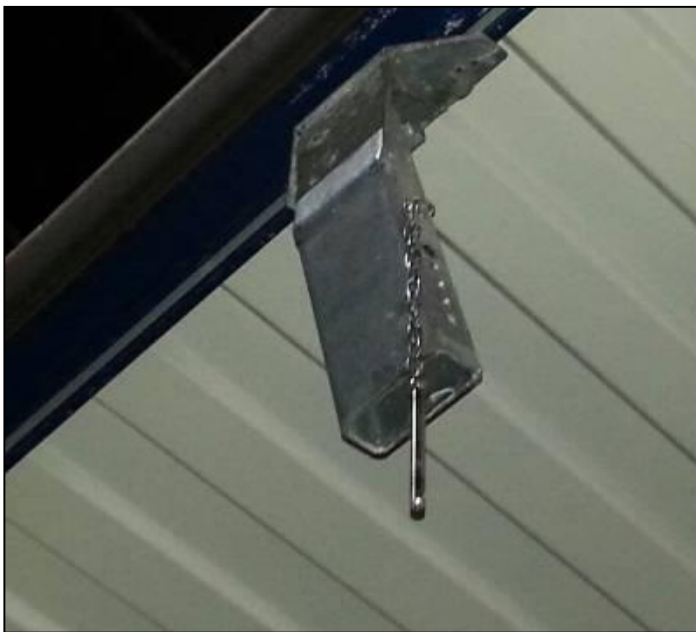
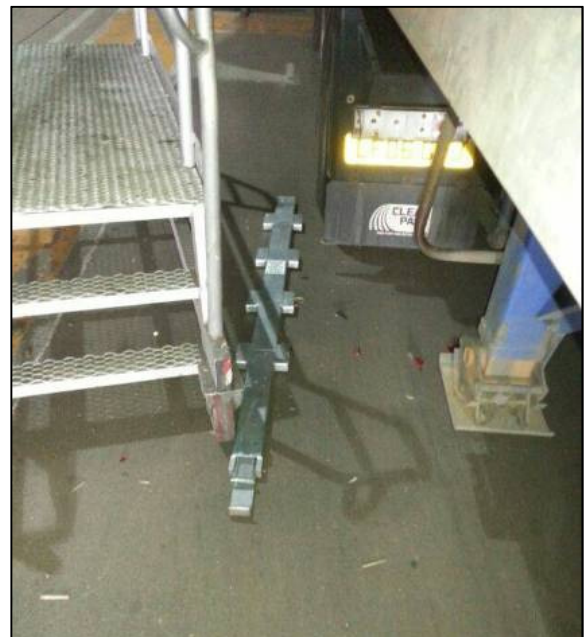
The IP (driver) was releasing a container support column on a swap body trailer as part of the normal loading process. The column became detached from its runners and fell suddenly to the floor hitting the IP on the fingers of his right hand.

- The roof support pin was not in place. The O/S curtain roller had been repaired but no sign off documentation detailing repair and checks was available.
- A spot check carried out on another incoming swap body of the same haulier revealed a roof support pin was missing.

- Hauliers to regularly maintain and check condition of the swap body container support columns, ensuring the pin is in place.
- Include the support column and pin checks on daily equipment checks.
- Ensure robust defect reporting procedures are in place, that the procedure has been communicated to all drivers and they understand how and when to report a defect.
- Keep a record of all repairs and ensure they are checked and signed off before the equipment is returned to use and the documentation can be made available in the event of an incident.
