Load Shift – Narrow Strip Product

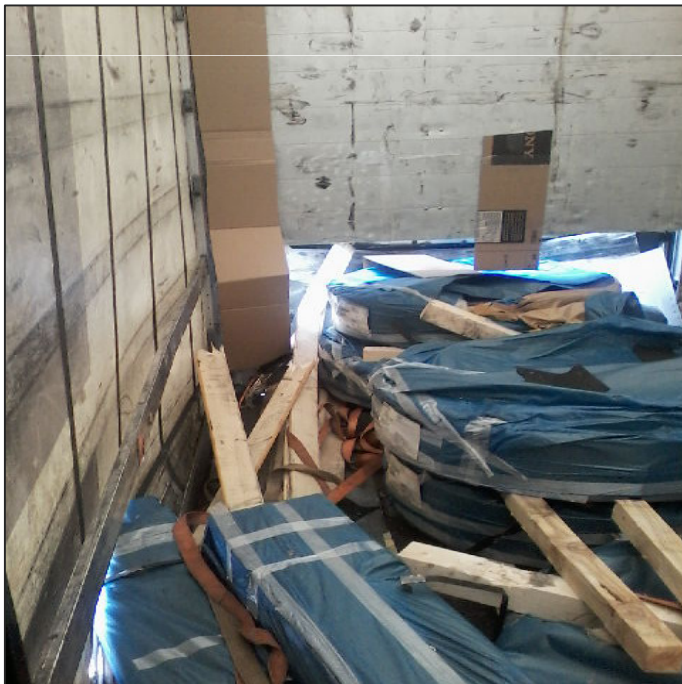
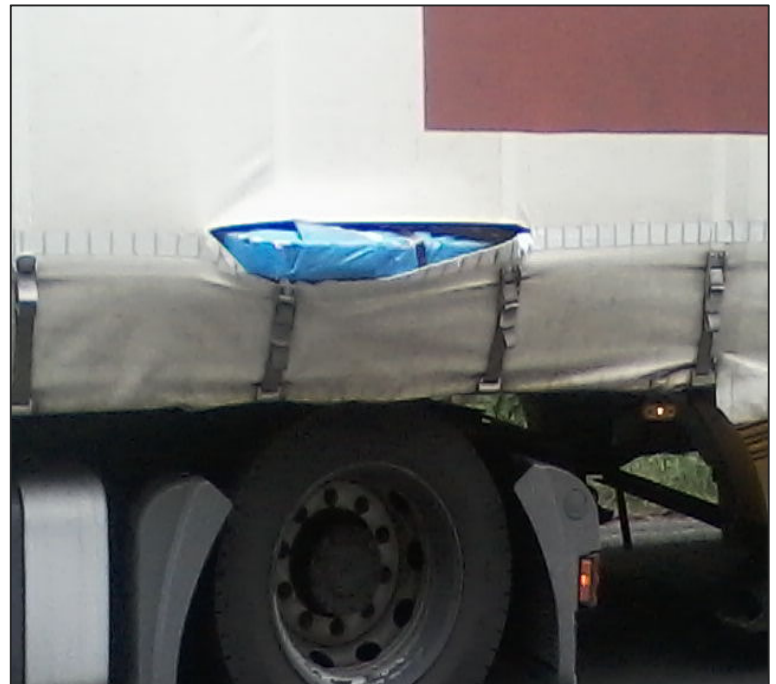
En route to customer the driver has braked heavily to avoid collision with another truck. The Narrow Strip coils and bundles being carried have shifted forward piercing the trailer headboard and through into the base of the rear part of the unit cab. Some of the product has sheared off to the side and cut through the trailer curtain.

- The product was not loaded to the headboard.
- Gaps between product.

- Load configuration and restraint to be reviewed by the loading customer.

- Where possible product **must be** loaded against the headboard / stanchions or false headboard.
- Gaps **must be** closed up to prevent movement.
- Edge protection **must always** be applied between the strap and sharp surfaces.
