Driver Injury – Cut and Bruising to Chin and Neck

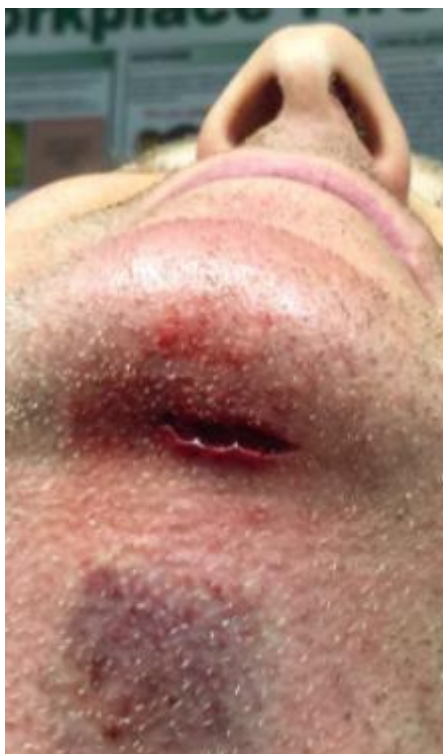
As the IP inserted the post into the socket the base of the post suddenly came out of the socket. As it came out of the socket the top of the post was leaning backwards and the bottom of the post flipped up and hit the IP hard beneath his jaw bone, causing a deep cut under his chin and bruising and swelling of the Adams apple area. IP received first aid treatment on site but was able to carry on with his duties.

Post is too big for socket, does not fit to base

- IP had worn all PPE and followed his companies SWP
- Loading site had forced the other posts in and were not able to be removed by hand.
- Previous driver had failed to report any problems with the stanchions.
- Stanchion posts were too big for sockets

- ✓ Ensure a defect reporting procedure is in place and is understood by all drivers.
- ✓ Ensure all reported defects are acted on and repaired promptly.
- ✓ If you see an issue with a trailer, report it immediately – don't leave it for the next driver **because it could be you!**

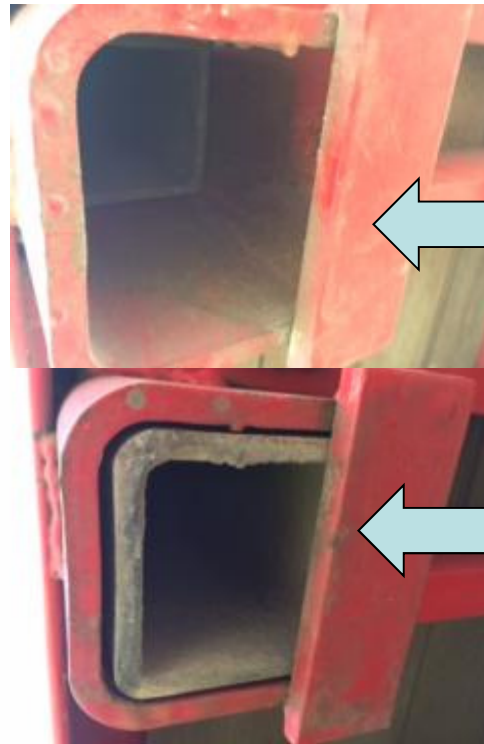
Correctly fitting post
