# alert bulletin

AB 005 2019

## Self (un)loading

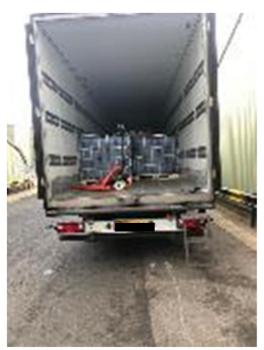
Driver was asked to assist and move the product closer to the rear of the trailer, using a pump truck. When moving the product, the driver lost control and the product pinned the drivers arm temporarily against the side of the trailer and the product.

- The vehicle was parked on a slope
- This was not the normal practice for unloading.
- The driver, although willing and helpful, was not trained in the use of the equipment

- If you are requested to assist in the loading or unloading process, please check back with your Traffic Office and with POFM.
- P&O recognises that drivers wish to be helpful, but they should not complete tasks, for which they are not trained.
