## Loss of Load in Transit

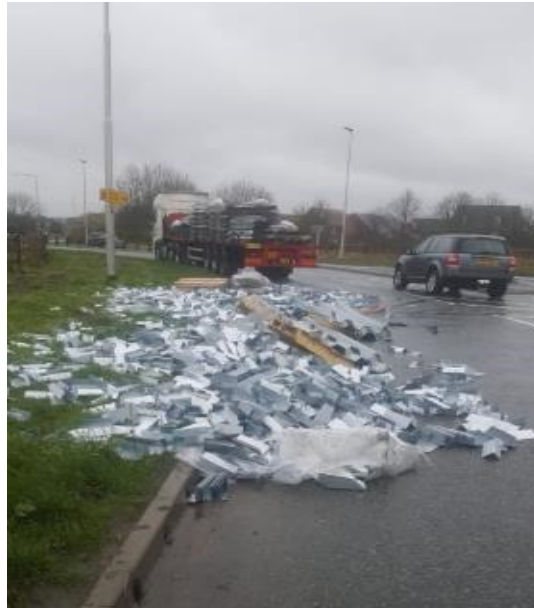
While on route to a customer delivery point two small pallets of product fell from the top of a trailer and landed on the roadside, spilling onto the carriageway. The incident occurred on a busy roundabout. There were no injuries.

- The trailer had been loaded with structural floor sections with timber dunnage between the layers.
- The pallets were around 4T in weight and placed on top of the structural sections of the load on top of the front stacks.
- This caused the timber dunnage in the front stack to break and fail and the load collapsed.

- ✓ Check and inspect loads allocated to them carefully.
- ✓ Do not accept any loads that are not configured in a way that can be safely secured and taken to road.
- ✓ Where a load build needs to be adjusted this must be raised with P&O immediately in order for it to be acted on and raised with the loading team on site.
- ✓ Check sheets must not be signed by drivers until they are completely happy their load is safe and they are willing to take responsibility for it.
- ✓ Ask yourself this question, would I be happy for me or my family to follow this load in a car?
