alert bulletin

AB 021 2019

Driver Injured During Loading

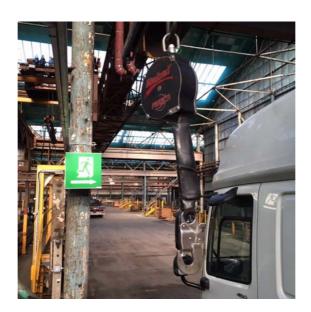
On 13th November a driver assisted the loading of another drivers trailer that was parked along side of his own trailer. The trailer was being loaded by overhead crane, and the loader required some timber dunnage to be positioned. The IP was wearing his fall arrest harness and was attached to the fall arrest block and lanyard, as required by the site for working at height, and stepped from his own trailer over to the 2nd trailer to move the timbers. As the IP moved forwards to he was pulled back sharply by the lanyard and he fell on his back onto the timbers of his own trailer.

Driver sustained muscle strain and bruising to his back. Over 7 day injury.

- The fall arrest block and lanyard operated correctly
- The IP made the decision to assist as he was wearing his fall arrest harness to assist the other driver who was not wearing his harness.
- The loading of trailers side by side in a bay was not an authorised procedure and not part of the Safe Working Procedure.

- ✓ Abide by the Safety instructions of the work area or site
- ✓ Wear the correct PPE for the loading site including the use of fall arrest harnesses and fall prevention systems where they are in place.
- ✓ Work responsibly, and take care of their own safety, and the safety of others.
- ✓ NEVER take short cuts in Safe Working processes
