Serious Near Miss – Road/Rail Interaction

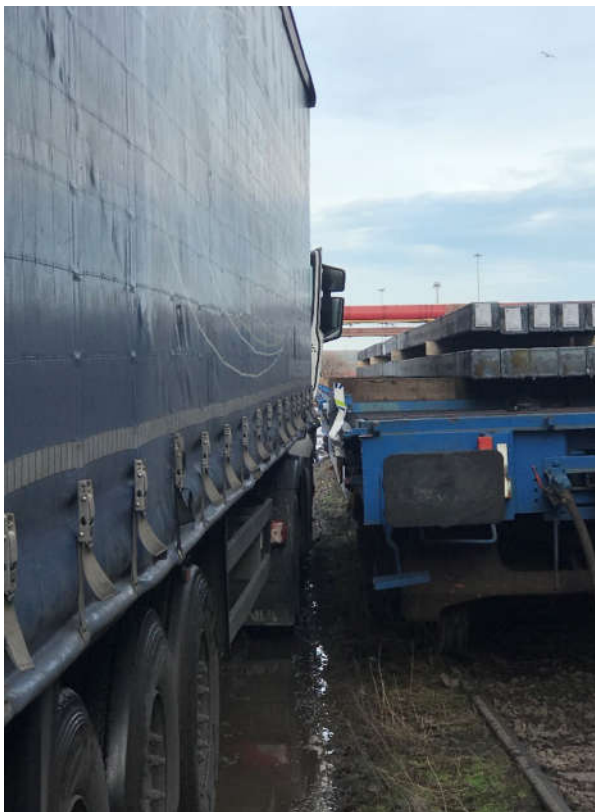
A driver was asked to prep trailer for loading and was stood at the rear of the trailer awaiting first pack of product to be loaded, a bang was heard. On investigating the noise it was observed that a rail wagon under power had collided with the offside front wing of the truck.

- Truck and trailer were parked too close to rail lines.
- Loading was not being carried out in usual area and space was restricted.
- Loco driver could not see truck as he walking was on the wrong side of the rail wagons.

- ✓ Ensure drivers are briefed on standards for parking in vicinity of rail lines, a **Minimum 3.0m Exclusion Zone to be observed at all times.**
- ✓ Challenge reasons for any change in usual loading practices or location and report them where necessary.
- ✓ Be aware of your surroundings at all times and if something changes then stop operations until it is safe to continue.
