Shifted loads – Stanchion Post Incidents

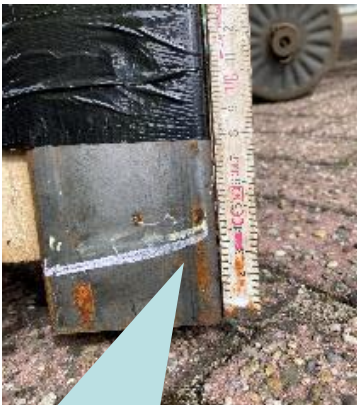
We have sustained 3 shifted steel loads in the last 3 weeks where the stanchion posts have moved due to not being seated fully in the pockets.

Issue:
Post not seated

Chalk line shows 3cm max depth post was seated

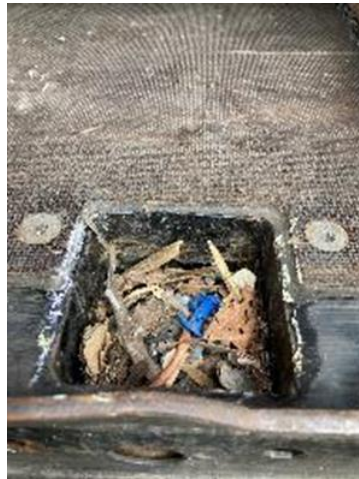
Root cause was debris in the pockets.

Cause:
Debris in Pocket
