2 INCIDENTS REGARDING SIDE BOARDS – MINOR INJURIES

IJMUIDEN Warehouse

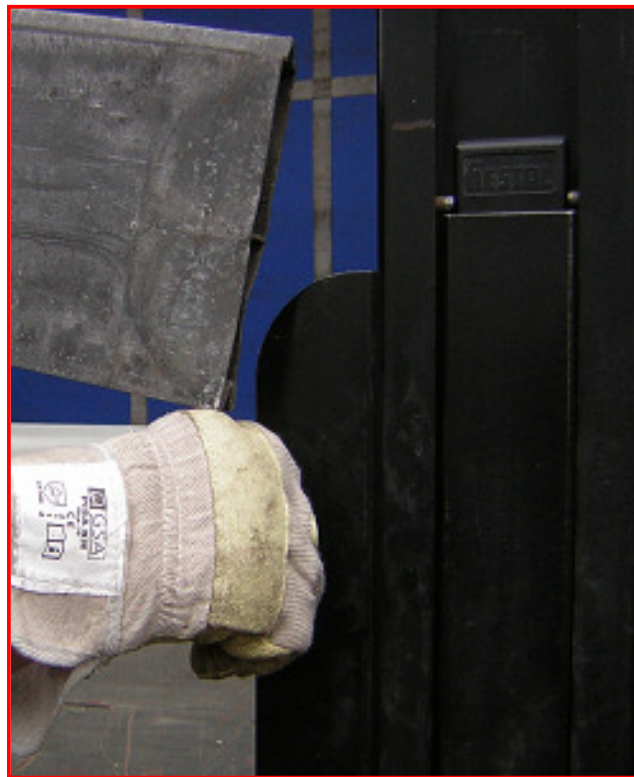
On 20th June an aluminium side board fell from the trailer and hit a driver's hand which resulted in a minor injury. The IP was taken to hospital where they found out the driver's hand was bruised. Whilst preparing the trailer for loading the driver opened the side curtain when the curtain caught behind one of the vertical side posts. This resulted in one of the side boards to fall, fortunately the driver was wearing full PPE as required, including cut resistant gloves.

On 18th August an aluminium side board fell inside the trailer and hit a driver which resulted in a minor injury - a cut on the left arm just above the wrist. When placing the side boards inside the trailer after loading the driver placed the side boards from bottom up. When finished the driver decided to re-position the lowest side board, however, when doing this, the highest side board fell down and hit the driver on the left arm. The driver was wearing his full PPE as required.

- Always wear full Personal Protection Equipment.
- Where there are facilities to safely gain access to trailer, first remove side boards **before** opening side curtain.
- When placing side boards work from bottom up.
- When removing side boards work from top down.
