Driver Injured by Curtain Tensioning Strap

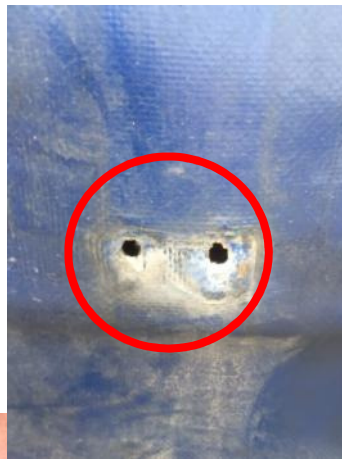
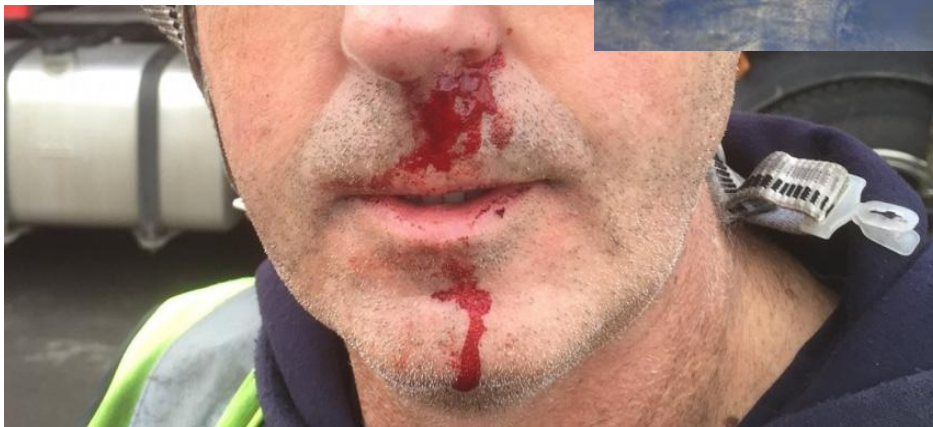
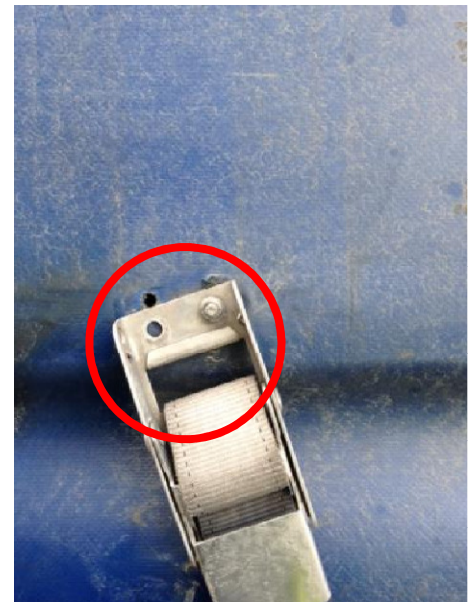
During loading process, Driver was moving his curtain towards the rear of the trailer when a curtain tensioning strap/buckle came away from the curtain as its pop rivet gave way, this caused the tensioning strap to strike the IP in the face and leave cuts to the lip and nose which required treatment at the Local Hospital.

- The correct safe working procedure was followed and full PPE was worn
- This type of Trailer used a Pop Rivet to attach the tensioning strap to the curtain, however there are several different types of fixings so cause of incident cannot be attributed to this one particular type.

- ✓ Always pull curtains open or closed using both hands and never pull on just one strap
- ✓ Always inspect fixings, regardless of type, prior to use for any signs of wear and tear
- ✓ Report any defects asap.
- ✓ Never use unsafe equipment.
- ✓ **Safety Glasses Must be worn throughout All trailer operations.**
