## Driver Fall from Height – Serious Injury

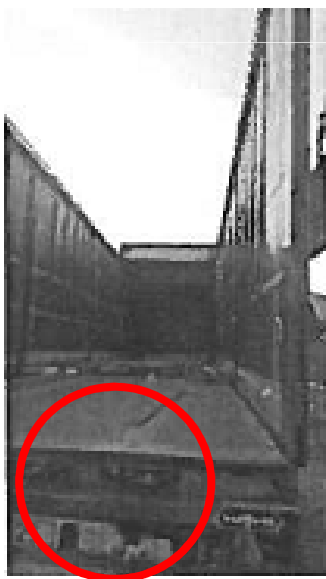
Driver was opening sliding roof with a roof pole. Driver was facing forwards. When he was struggling to release the header bar and release cord, the driver slipped and fell backwards. He fell on to the rear of the trailer before landing on the ground. Driver suffered 5 broken ribs and remained in hospital for 8 days.

**Driver impact with trailer**

- ✓ All Hauliers to review their own procedures and ensure their Drivers are competent in Sliding Roof operations
- ✓ **ALL P&O SAFE WORKING PROCEDURES ARE AVAILABLE FOR DOWNLOAD FROM OUR WEBSITE – [www.poferrymasters.com](http://www.poferrymasters.com)**
- ✓ Review length of Roof Poles issued (longer poles allow operation from the ground).
- ✓ Implement process for checking and lubricating roofs.
- ✓ Report any defects and never use unsafe equipment
- ✓ **PROACTIVE INCREASES IN CHECKS AND DEFECT REPORTING WILL REDUCE THE POTENTIAL FOR THESE TYPES OF ACCIDENTS!**
