Driver Fall from Height – Serious Injury

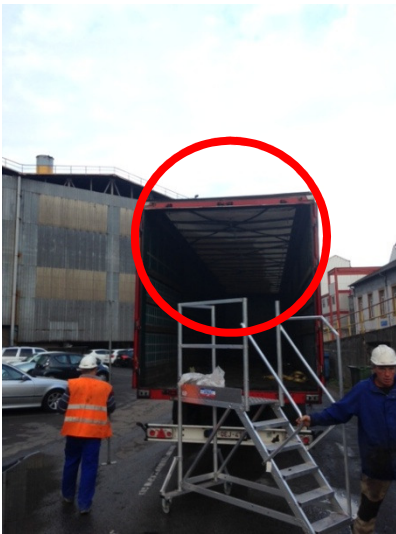
Driver was attempting to close sliding roof after off loading, the roof became stuck and the driver climbed onto the top safety guard rail of the safety platform. He was instructed by site staff several times to cease and return to the correct working level but disregarded all instructions. After attempting to free up the sliding roof a 3rd time the driver slipped and fell off the guard rail onto the platform ladders and eventually the ground injuring his knee. Driver could not continue with his normal duties and was returned home to rest his injuries.

Driver stood on top guard rail

- Roof jammed on closing causing driver to try free up.
- Driver misused platform provided.
- Driver did not follow training or company procedures.
- Driver did not have his own roof pole.
- Driver disregarded site personnel.
- Driver was wearing PPE.

- ✓ All Hauliers to review their own procedures and ensure their Drivers are competent in Sliding Roof operations.
- ✓ At this Location **All** sliding roof operations to be carried out from the **Ground ONLY**.
- ✓ **Communicate ALL issues with site staff, a local solution may exist.**
- ✓ **ALL P&O SAFE WORKING PROCEDURES ARE AVAILABLE FOR DOWNLOAD FROM OUR WEBSITE – www.poferrymasters.com**
- ✓ Review length of Roof Poles issued (longer poles allow operation from the ground).
- ✓ Implement process for checking and lubricating roofs.
- ✓ Report any defects and never use unsafe equipment.
- ✓ **PROACTIVE INCREASES IN CHECKS AND DEFECT REPORTING WILL REDUCE THE POTENTIAL FOR THESE TYPES OF ACCIDENTS!**

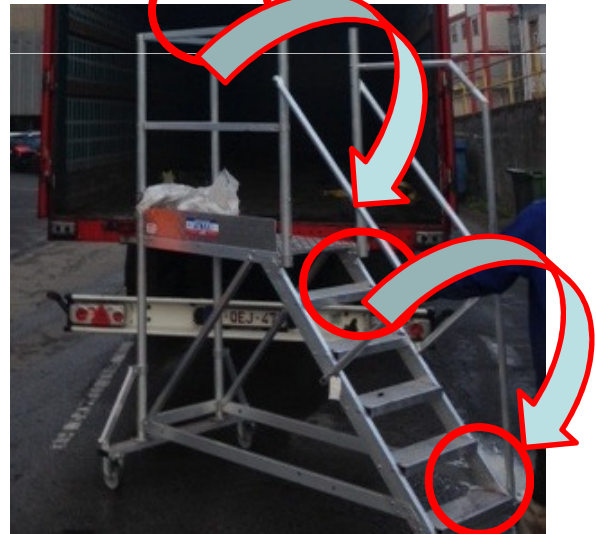
2.5 metres Fall - Hard landing
