AB / 005 / 2018

## **Shunt Straps**

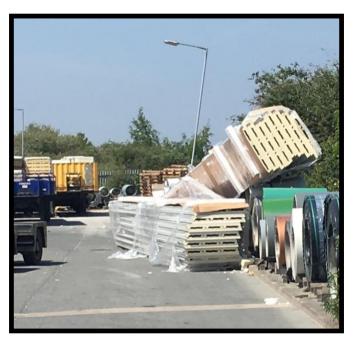
On 23<sup>rd</sup> May 2018 a driver collected a flatbed trailer loaded with four 13m bundles of building panel from the trailer park. The driver coupled up and pulled out of the parking bay and out of the trailer park on his way to the load securing area. As he turned right and drove along the access road two of the packs on the left of the trailer fell off and landed on the access road and coils stored in the area.

- Shunt straps had not been applied as per P&O and customer instructions.
- Driver did not follow the shunt strap procedure when moving loaded trailers on customer sites.
- ■The driver is experienced and fully trained in P&O and the customers site safety standards and load securing process.

- 1. Shunt straps **MUST** be applied to **ALL** loads when moving around on customer sites. A minimum of 2 per bundle (dependant on load).
- 2. Hauliers are required to ensure all drivers have received the shunt strap instruction.
- 3. Site staff will be checking loaded trailers moving around site. Drivers who fail to apply shunt straps will be reported immediately.
- 4. CCTV cameras are in operation and footage is checked regularly.
