## Load Shift – Coil on Plastic Pallets

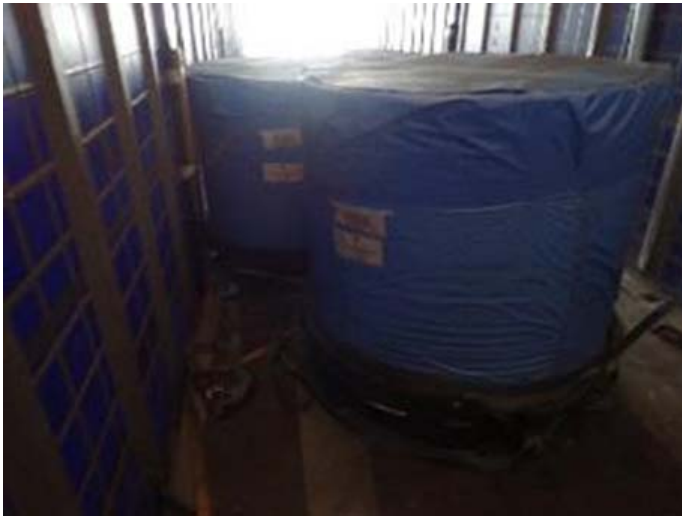
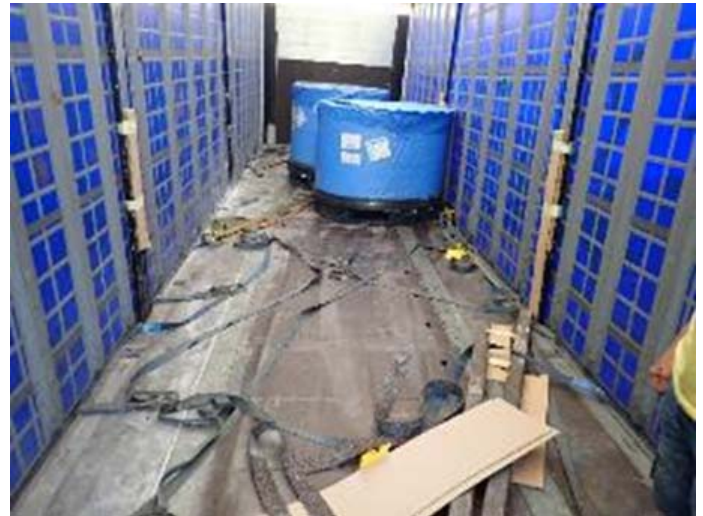
While en route to a customer the driver had to make a heavy braking manoeuvre to avoid collision with a third party vehicle. The two coils on plastic pallets being carried have shifted forwards breaking some of the securing straps. The coils collided with each other causing damage to the coils. The coils stayed within the trailer and there were no injuries.

- The trailer bed was covered in plasterboard dust from the previous load
- Anti-slip mats had been positioned on top of the powder
- Many of the fixed securing straps on the trailer had cuts, chaffing and were in poor condition

- ✓ Ensure trailers are in a fit condition to load.
- ✓ Ensure trailer beds are clean and free from all slip and trip hazards and contaminants from previous loads, rubbish and debris.
- ✓ Inspect securing straps and ratchets for cuts, knots, punctures and chaffing. Reject faulty or poor condition straps and ratchets and report them as defective immediately.
- ✓ In the event of an RTA, heavy or emergency braking incident drivers must stop at a safe place, visually inspect the load and securing straps, report signs of movement or damage to P&O immediately. Wait for P&O instruction before continuing their journey.
