Driver Injury From Faulty Roof Support

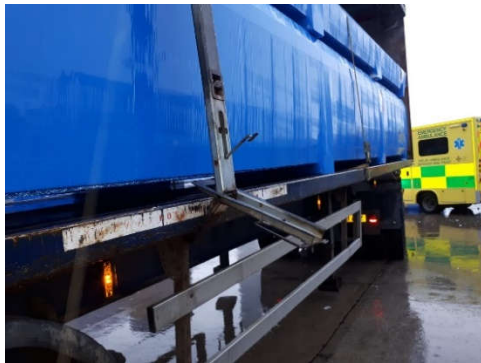
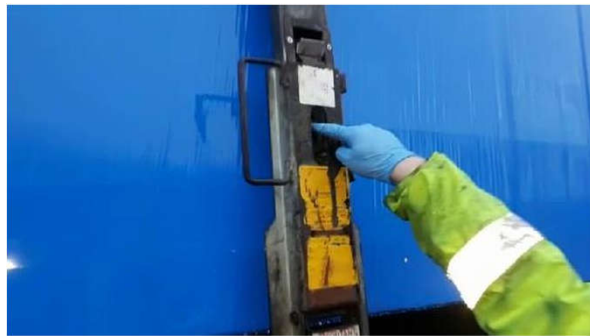
On 28 July at 19.30 pm a driver was replacing a trailer roof support in position after the trailer had been loaded at customer site. He had inserted the post and pushed the locking arm up into position. As he started to turn away from the trailer the locking arm sprung out suddenly and struck the driver hard on the top left side of his head. The driver was knocked unconscious for approximately 5-7 minutes before being discovered by the customer staff, and medical assistance was given.

- The driver was following the procedure correctly
- The driver was wearing the correct PPE for the site
- The roof support locking arm safety catch was faulty and failed

- ✓ Check and inspect trailer roof supports carefully and ensure the retaining bolts, safety catches and rollers are in place and working correctly.
- ✓ Ensure all trailers are in a condition that is fit for loading and safe for all persons who may come handle the trailer.
- ✓ If a changeover trailer is found have a defect **do not leave it at the site to be "somebody else's problem"**, report it to your manager immediately for a repair to be arranged.
- ✓ Ensure roof supports and moving parts are inspected regularly and included in service and maintenance regimes.
- ✓ Have a robust defect reporting and maintenance regime in place, and ensure drivers and operational staff follow it.
