Injury as a Result of Not Following Procedures

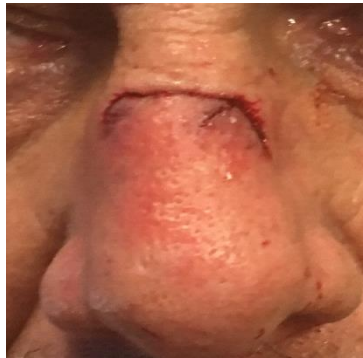
On 7th August 2019 a driver was preparing a trailer for loading. The driver had already removed all the roof support posts from the near side of the trailer and moved around to the off side to remove the remaining posts. He started to remove the support post from the off side middle of the trailer when the support he was handling sprung out and hit him across the bridge of his nose.

He was released a short time afterwards with a cut and bruising to his nose. No fractures or concussion.

- Driver was qualified and wearing the correct PPE for the site
- Driver had been trained in the POFM SWP for roof support removal and replacement.
- Vehicle was inspected and no fault was found with the support
- Driver removed all the posts on one side of the trailer first, which put the weight of the roof on the remaining supports, and did not stand to one side of the posts as he undid them but stood directly in front.
- Driver did not follow the safe procedure for removing roof supports correctly

- ✓ NEVER remove ALL posts from both sides of the trailer.
- ✓ Remove only the posts that need to be moved to facilitate loading, ensure they are replaced before moving to the next post.
- ✓ Always stand slightly to the side when working with roof support posts.
- ✓ The centre post should not be moved more than third of the distance from the front or the rear.
