## Driver Injured by Moving Vehicle

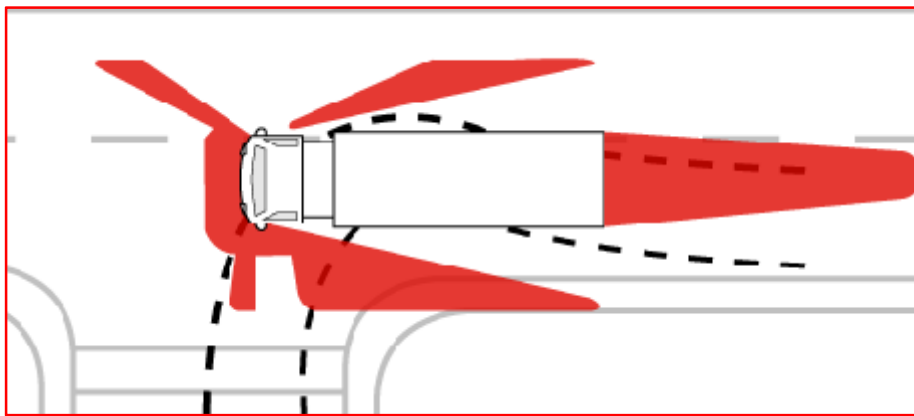
A driver who was working beside his truck and trailer at the Stop line in the front of the middle set of gantries was struck, and crushed against his cab unit by the rear of a flat bed extended trailer as it pulled out of the first set of gantries and turned right onto the exit road.

- The driver of the moving vehicle was connected to an Extended trailer with a long length load, and had used the first (far right) set of gantries. The rear of the trailer moved over to the far left as the driver turned right.
- The injured driver was wearing his PPE including hi-visibility vest, standing beside his drivers door unlocking it. The injured driver did not appear to notice the vehicle moving closely beside him.
- The driver of the moving vehicle did not see in his mirrors the driver to his left standing beside his truck in the adjacent lane.

- ✓ Brief drivers:-
  - ✓ Be clear and stay clear
  - ✓ See and be seen
- ✓ Drivers and workers must be aware of where they are working and take additional care when working in areas where other vehicles are operating.
