Driver injured whilst collecting Loaded Trailer

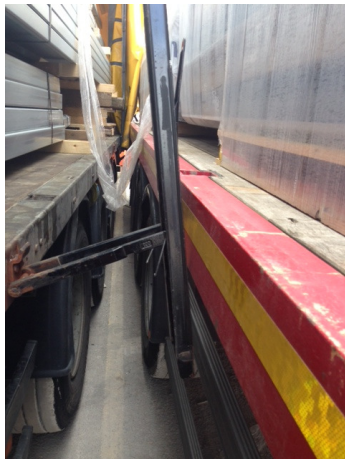
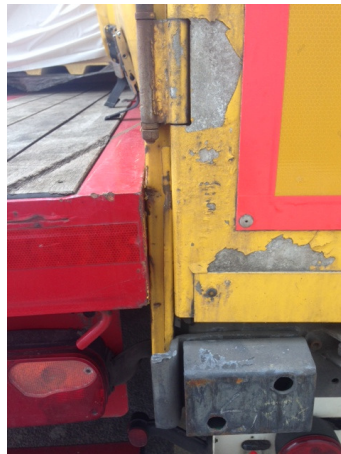
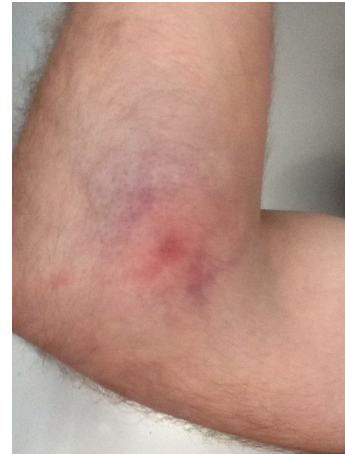
Driver (IP) was collecting a trailer from the trailer park. Another loaded trailer was parked very close next to it. As he attempted to go down the side of the trailer, he has brushed past the roof support which has sprung out trapping his elbow against the trailer parked next to his trailer. IP managed to free himself from being trapped between the roof support and trailer and walked back to the front of the trailer. He then stood for some time recovering and holding his elbow. After, he called his manager to report the incident and then went to the driver reception where he received treatment.

- Trailer side post (Roof support) had not been correctly replaced
- Trailers parked too close together

- In such situations drivers should assess the situation
- Access the trailer park brake via safest route possible and release the trailer park brake
- Pull the trailer forward to allow suitable and safe working area
- After removing side posts (roof supports), please make sure they are correctly and securely replaced.
