## Uncoupling Event

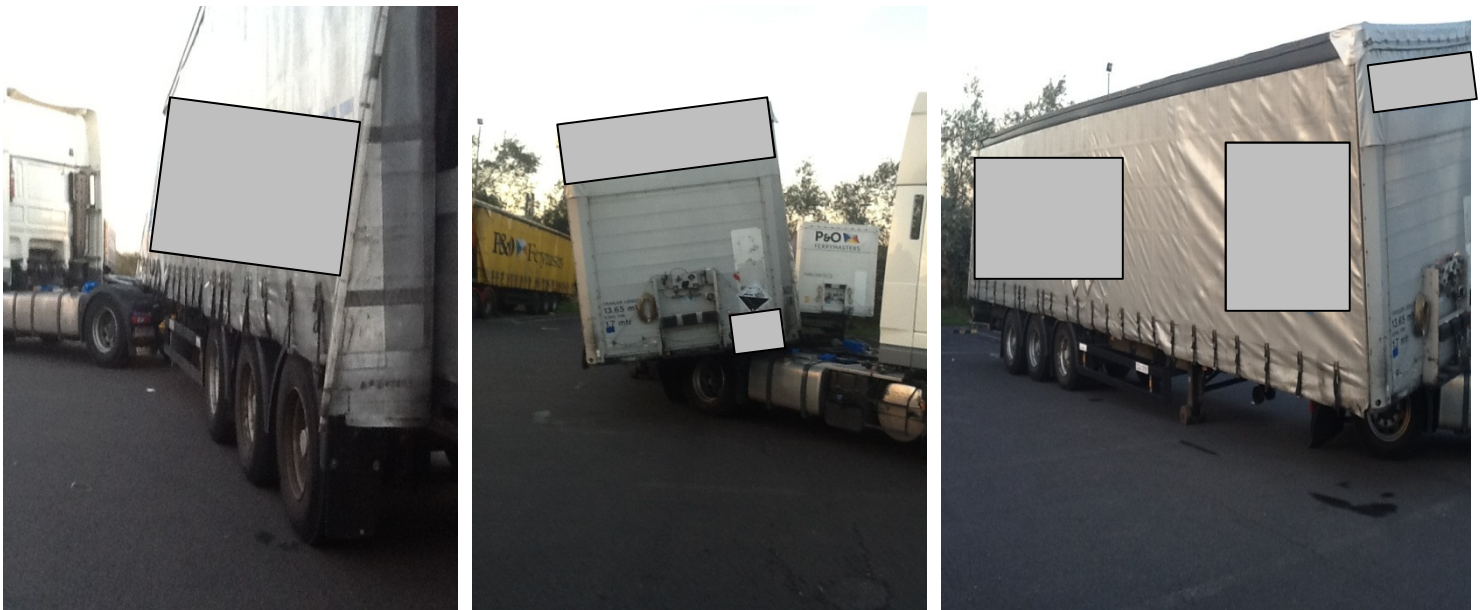
Whilst carrying out a routine trailer changeover, driver has reversed under trailer and carried out coupling up process. On exiting parking bay, driver has realised that the tractor and trailer have not coupled correctly and has brought vehicle to a stop before the trailer has slipped off the turntable. Landing legs were wound down and load recovered. Driver had not restrained load prior to moving off.

- Driver failed to engage correctly and check 5<sup>th</sup> wheel locking pin on the trailer was fully engaged and secured.

- Haulier to re brief ALL drivers on coupling procedures.
- Haulier should audit drivers on coupling/ uncoupling procedures against recognised SSOW.
