## Curtain Buckles

AB 013 2018

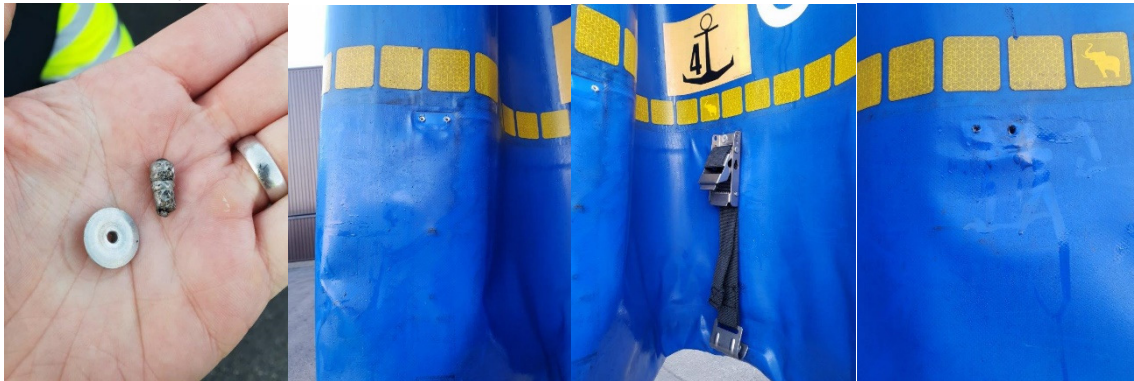
Driver was pulling the curtain open using the buckles. One of the buckles gave way causing whiplash and concussion injuries to the driver.

On further inspection it was found that the buckle had been incorrectly fitted with rivets. There was evidence of 2 further buckles being incorrectly fitted with rivets

- Standard at manufacture is for buckles to be secured with backplates, bolts and nuts
- It cannot be conclusively identified where and when these Buckles were incorrectly riveted

- Please carefully check buckles on curtains. They should be fitted with bolts, nuts and backplates
- If you identify a buckle is fitted with rivets, please report this as a defect
- Follow guidance in Safe Working Practice
