Loss of Load in Transit – Near Miss

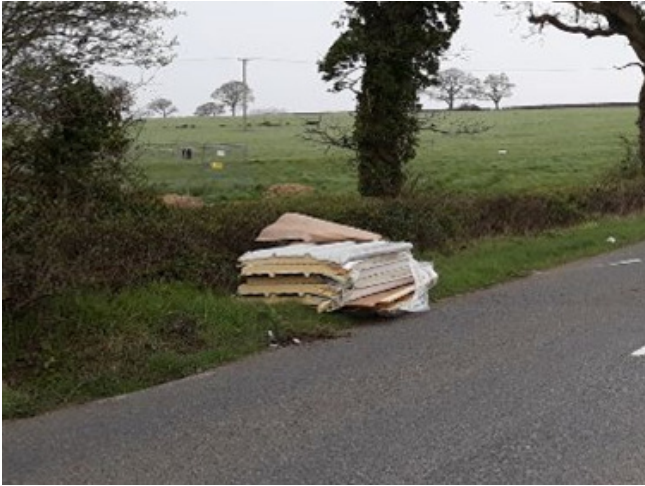
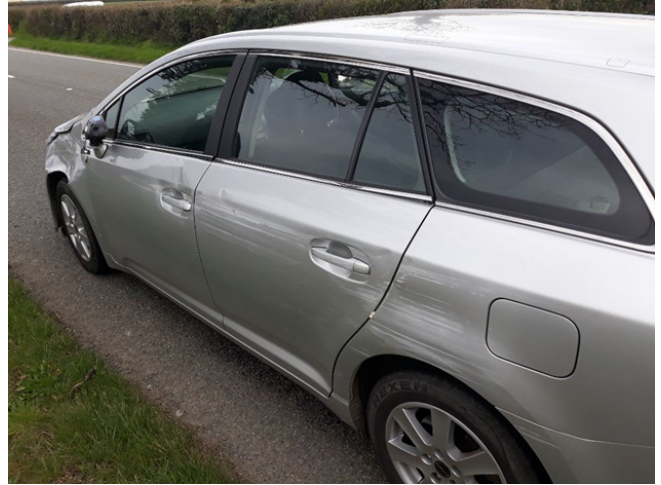
While on route to a customer delivery point a pack fell from the trailer and struck a passing vehicle causing severe damage. No injuries sustained to persons.

- The trailer was loaded with product for multiple delivery drops.
- The driver was advised by load checking staff to have the load re-configured before leaving the loading site due to the potential unsupported load after the first drop, but the driver was short on time and did not want to wait.
- Load checking staff did not prevent the load from leaving site and arrange a re-stow.
- The first drop was completed and product unloaded from off-side. A stack of product was remaining on the near-side, secured with a hammock strap over the top.
- The product moved within the packaging during transit, the hammock strap lost its hold and the pack fell.

- ✓ Check and inspect loads allocated to them carefully.
- ✓ Do not accept any loads that are not configured in a way that can be safely secured and taken to road.
- ✓ Take extra care if the load is a multi-drop and ensure the load can be adequately secured after each delivery stage.
- ✓ Where a load build needs to be adjusted this must be raised with P&O immediately in order for it to be acted on and raised with the loading team on site.
- ✓ Check sheets must not be signed by drivers until they are completely happy their load is safe and they are willing to take responsibility for it.
- ✓ Ask yourself this question, would I be happy for me or my family to follow this load in a car?
