Incidents with roof supports (side posts)

In the last few months we have received several incidents relating to roof supports / side posts.

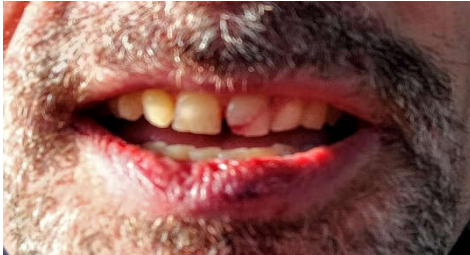
Side post hit driver in his face:

IP removed the middle post and tried to release the last post. Due to the tension on the leveller the leveller hits the IP in his face. Resulted in broken tooth and lip.

- Check how many posts can be removed and **Always follow the SWP** that could be found on : <http://www.poferrymasters.com/carrierinfo/health-and-safety/operational-standards/>
- Don't open levellers or doors in a direct field of vision and wear a helmet.
- If a forklift or crane is witnessed hitting a roof support / sidepost, report the trailer for inspection, as hidden damage may be present
- Each defect needs to be reported immediately

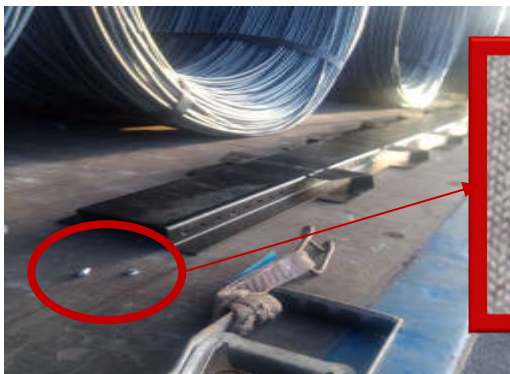
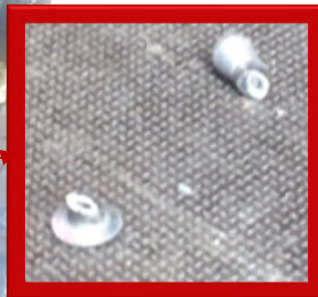
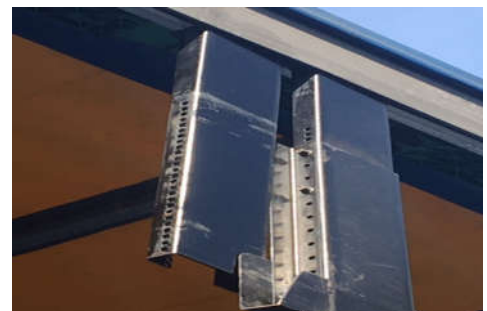
Support has fallen and narrowly missed hitting Operatives (5 incidents):

- 5 Incidents have happened on 4 different trailer types / manufacturers
- Following engineering inspection there is evidence with each incident that either equipment has been damaged and incorrectly replaced or partially damaged and not reported.
