Serious Near Miss – Load Fall from Overhead Crane

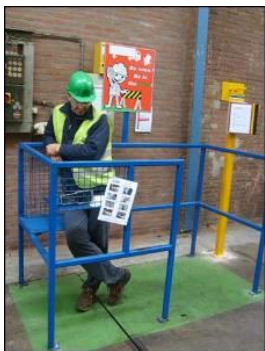
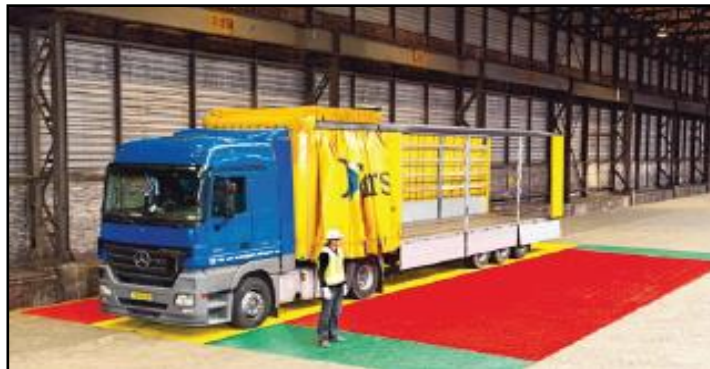
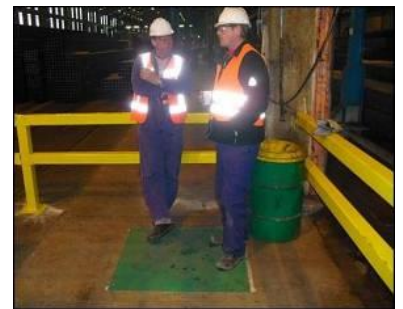
A trailer was being loaded by over head crane by a loader using a remote control from the ground. The driver was standing beside the trailer undoing the curtains when the crane operator brought over the next steel bundle. The bundle was suspended over the trailer and as it was lowered down the front sling strap slipped off the bullnose of the crane. The steel bundle fell onto the trailer bed. Luckily, the driver escaped without injury.

- ✓ **Where drivers are not directly involved in the loading or unloading process, they should wait in the driver safe zone where they cannot be injured should something go wrong during loading. Ask site staff where they are if not displayed.**
- ✓ **Drivers should See and be seen**
- ✓ **Never stand beneath operating overhead cranes or crane flight paths**
- ✓ **Do not approach vehicles until instructed to do so**
- ✓ **Always stay in clear vision of forklifts or crane operators**
- ✓ **Loading teams and crane operators should practice a “Can’t See – Can’t Work” procedure**
